Engineering Geological Studies along the Tinpile Banchare Dada Road, Central Nepal

Matrika Prasad Koirala and Daigoro Hayashi

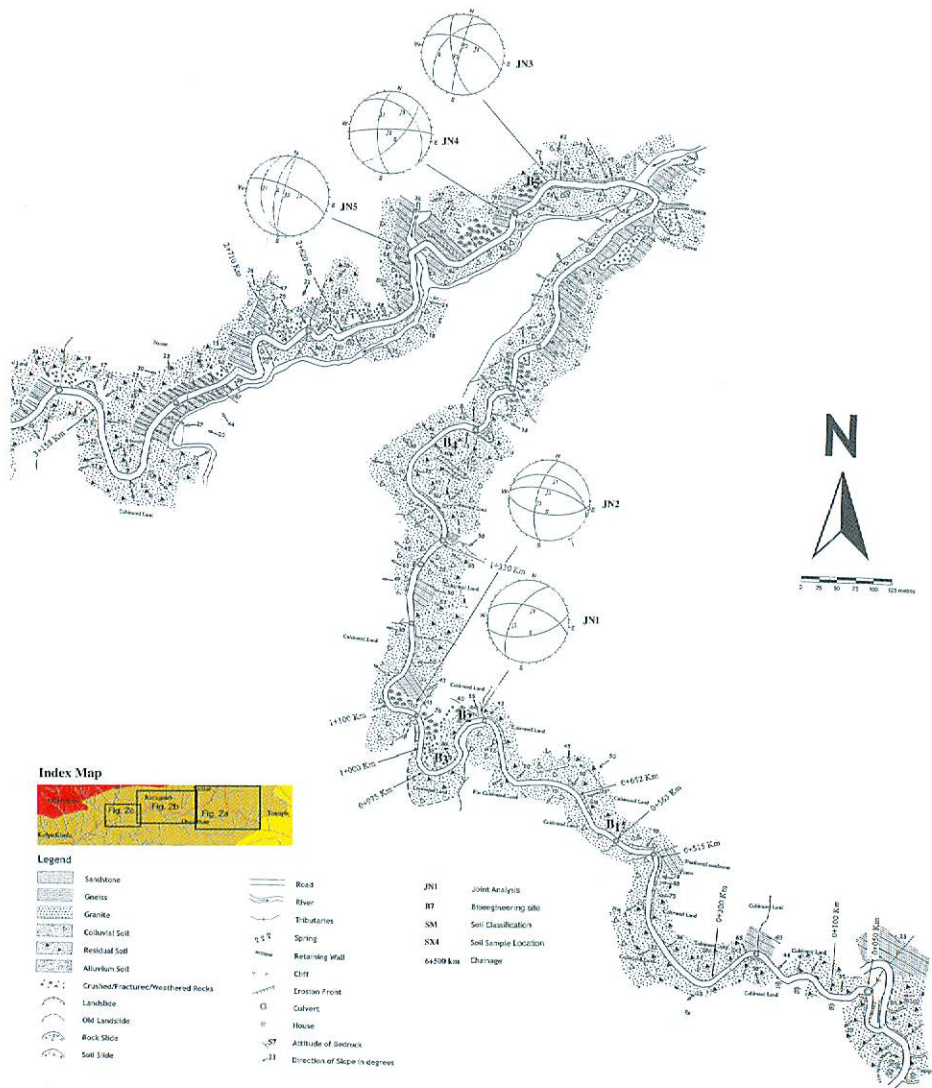
Figure 2a. Engineering geological map along the Tinpiple-Banchare Dada road (modified after Koirala, 2003)

The alignment begins from the Tiniple (Figs. 1, 2a). It is almost horizontal and runs towards west and passes through the middle slope of the hill. The natural slope lies between 20° and 30° (Fig. 2a). The cut slope in this section varies from 40° to 80° (Fig. 2a). The up slope area is predominantly covered by cultivated land and settlement with a few shrubs and the down slope is covered by cultivated land where there are a few rock exposures of highly weathered interbedded sandstone and gneiss at 0+250 km and 0+515 km. The attitude of sandstone is S43° W /41° NE. The sandstone is medium grained dark grey micaceous. The soil types found in the area are colluvial and residual. The soil found at the beginning of the road is classified as ML and the soil at the remaining section is classified as SM and depth is greater than 6m. The area is fairly dry and few seasonal gullies are encountered along the alignment, which are less active and of low gradient. The area is relatively stable and hazard level is low. One small landslide is activated due to high cut slope at about 0+420 km. No major problem is anticipated within this section in the future.

This is an ascending section and runs through the middle slope of the hill following northwest trend. The natural slope angle ranges between 5° and 15° (Fig. 2a). The cut slope of the section varies from 45° to 80°. The majority of the area is covered by cultivated land. The alignment runs towards west at the beginning and then towards north. The up slope area is covered by cultivated land and settlement. The down slope area is covered by cultivated land. The down slope is covered by colluvial soil (GP) and the up slope is covered by residual soil (SM). The soil in this area has thickness of greater than 6m. Between 0+800 km to 1+000 km sandstone and gneiss are interbedded. The attitude of bedding is N70° W / 60° NE. At chainage 0+563 km a 40 m x 20 m soil slide (B₁, Fig 2a) is present. Within the slide small gullies are developed (Fig. 3). This

This is the ascending section of the road and trends towards southwest. This section follows the trend of Thulo Khola and from 2+980 km it bends towards northwest. First 550m consists of colluvial soil (GM) on the both up hillside and the down hill side of the road. The remaining portion of the road consists of both residual (SM) as well as colluvial soil. The soil depth reaches up to 3-6m. Between 2+200 km to 3+000 km the up slope consists of rock exposures, the rock type is granite, sandstone and gneiss. The granite and gneiss are highly weathered and the sandstone is slightly weathered. The attitude of the bedding plane is N60W/63° NE. Joint analysis at chainage 2+115 km shows that joint 1&2, 2&3 and 1&3 produce the lateral wedge and the entire three wedge formed dips greater than the cut slope so they have probability of failure (JN₃, Fig 2a).

central wedge. The wedge formed by 1&3 and 1&2 are stable as wedge formed dips opposite to the cut slope. The central wedge formed by the joint 2&3 is also stable as it dips less than the cut slope (JN₄, Fig 2a). Joint analysis at chainage 2+475 km shows that central wedge formed by the joint 2&3 is unstable and the central wedge formed by the joint 1&2 is stable. The lateral wedge formed by the joint 1&3 has probability of failure (JN₅, Fig 2a). The natural slope in this section varies from 23° to 60° and the cut slope varies from 27° to 68°. Retaining walls are constructed on the down hill side of the road where the cut slope more than 60°.

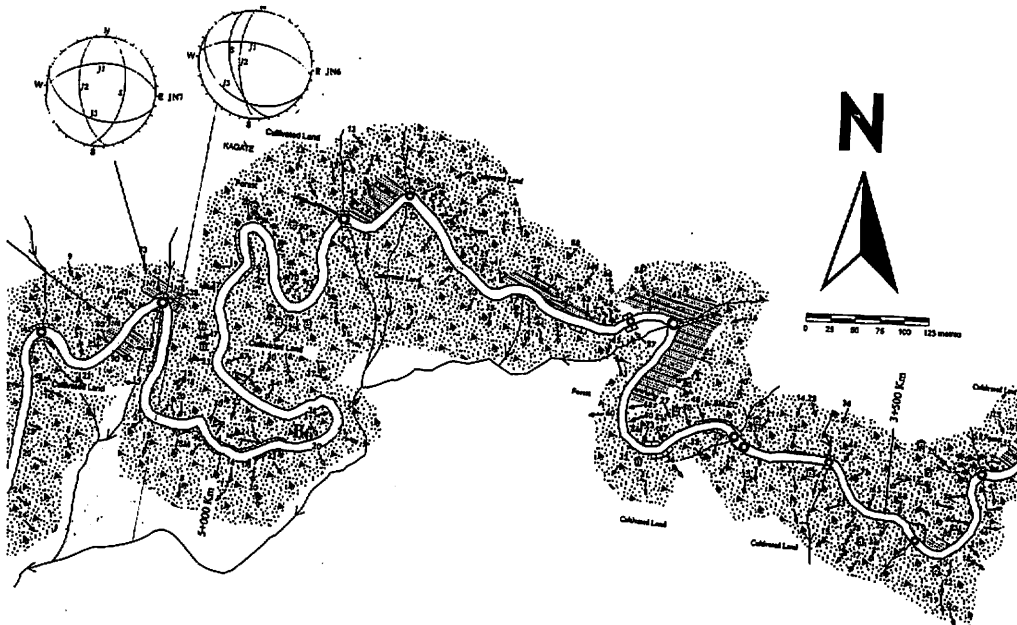
Figure 2b. Engineering geological map along the Tinpiple-Banchare Dada road (modified after Koirala, 2003)

The road in this section follows general trend of west with sharp bends at 3+200 km (towards south west), 3+800 km (towards north west), and at 4+000 km (towards west). This is the descending section of the road. The soil type in this section is classified as SM at the beginning of the section and SM - SC at the end of the section. Both the up slope and down slope is cultivated land and the soil depth is greater than 6m. Between 3+200 km to 3+300 km, 3+900 km to 4+120 km, 4+450 km to 4+500 km, sand stone, granite and gneiss are well exposed. Sandstone is slightly weathered and the gneiss and granite are highly weathered and fractured. The attitude of the bedding plane is S67° E/83° NE. The natural slope in this section varies from 13° to 28° and the cut slope varies from 38° to 71°. This portion of the road crosses many minor streams. A small soil slide is activated due to high cut slope at 3+450 km (Fig. 2b).

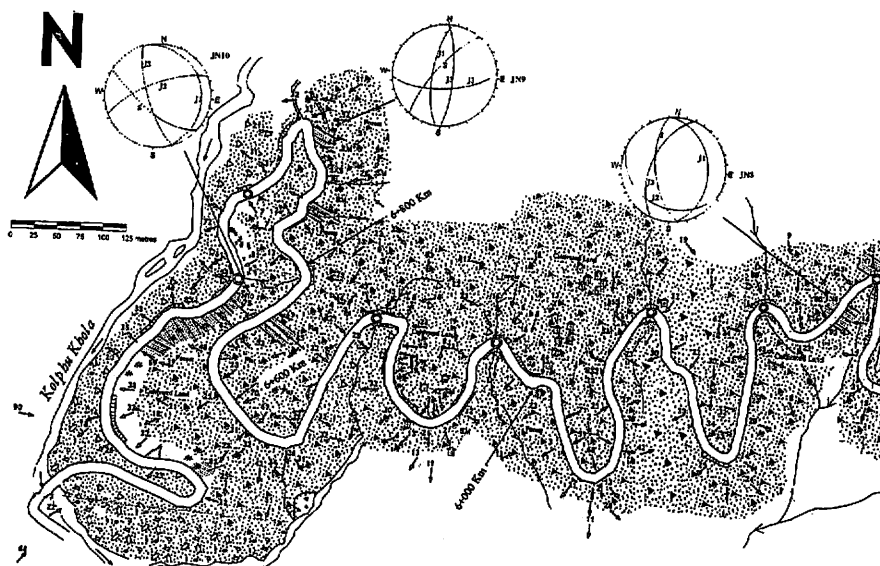
Figure 2c. Engineering geological map along the Tinpile-Banchare Dada road (modified after Koirala, 2003)

This is the descending section up to Kolphu Khola at 8+200 km and after that the section is ascending and follows the general trend of southwest with the sharp bend at 7+600 km towards west. The down slope up to 7+600 km consists of the residual soil and the up slope consists of the colluvial soil. The residual soil is classified as SM and the colluvial soil is classified as GM. The remaining section of the road consists of alluvial soil and is classified as GM. Between 7+300 km to 7+400 km the slightly weathered sandstone beds are well exposed. The attitude of the bedding plane is $S86^{\circ} E/62^{\circ} NE$. Joint analysis at chainage 7+220 km shows, 2 central wedges are formed by the intersection of the joint 1&3 and 2&3, and the wedge formed by joint 1&3 has probability of failure as it has same dip amount to the cut slope. The lateral wedge formed by the intersection of the joint 1&2 is stable (JN_9 , Fig. 2c). The joint analysis at chainage 7+525 km shows that central wedge formed by the intersection of joint 2&3 has high dip but its direction is in the other direction thus it is rather safe. The lateral wedge formed by the intersection of the joint 1&2 has low dip thus it is also structurally safe (JN_{10} , Fig. 2c). Highly weathered

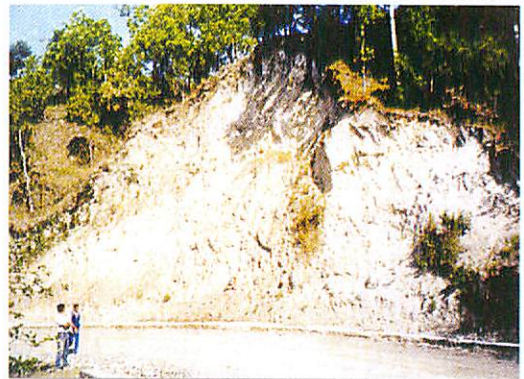
Fig. 4 Bioengineering site B2 at chainage 0+860 km, view towards northwest

site can be stabilized by the use of jute netting and diagonal grass lines, a simple bioengineering technique (Koirala, 2005). Another small slide (B₂, Fig 2a) is present at chainage 0+860 km (Fig. 4). Contour grass lines or jute netting and randomly planted grass can be used as effective bioengineering measure for this site (Koirala, 2005). The joint analysis at chainage 0+880 km shows that the intersection between the joint 1 and 2 produce the wedge, which is in the opposite direction of the cut slope thus this location seems structurally safe considering any failure (JN₁, Fig 2a). At chainage 1+000 km a small landslide occurs (B₃, Figs 2a & 5). Grass seeding, mulch and wide mess jute netting is considered as the effective bioengineering technique for this site (Koirala, 2005).

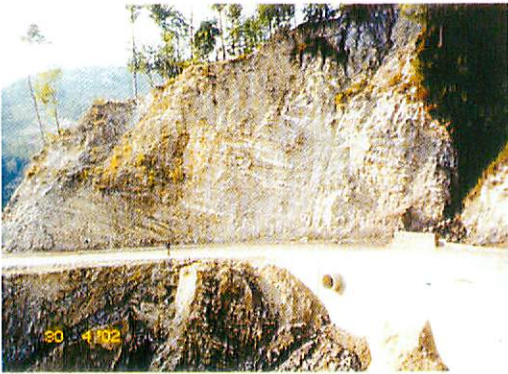
Fig. 7 Bioengineering site B5 at chainage 2+180 km view towards northwest

A soil slide is present at chainage 2+180 km (B₅, Figs 2a & 7). It consists of completely weathered rocks. It is due to slope cutting. Direct seeding of shrub or small tree is an effective bioengineering method (Koirala, 2005). Joint analysis at chainage 2+210 km shows that joint 1&2, 1&3 produce the lateral wedge and 2&3 produce the
