# Engineering Science and Technology, an International Journal

## Horizontal end crack control and load-bearing capacity performance of hollow-type pretensioned girders through experimentally calibrated finite element models

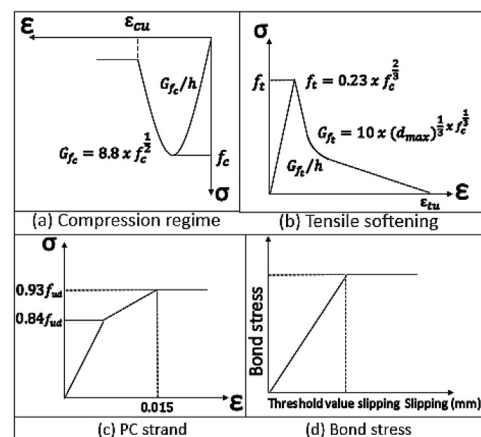
**Fig. 11.** Constitutive laws for analysis models [29].

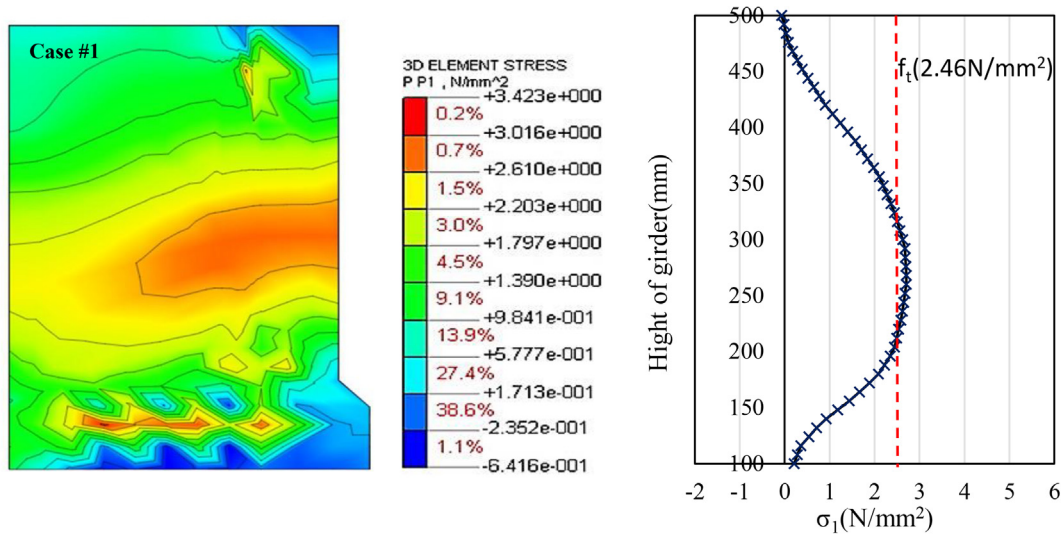
Fig. 12. Principal stresses in the half cross-section of girder in Case #1.

To examine the stress state associated with horizontal cracking at the ends of the BS12 girder, the stress contour, principal stresses along the vertical edge of the end section, and crack locations are shown in Figs. 12 and 13. In Case #1, with all strands fully bonded, the principal stresses in the end zones of the girder were greater than the tensile strength of the concrete, and horizontal cracks were likely to occur near the middle of the outer edge, as shown in Fig. 14. However, debonding four alternating strands in the first row of the lower flange reduced the principal stress below the tensile strength, eliminating horizontal cracking in the end zones of the BS12 girder, as shown in Fig. 15. Based on the numerical results, the actual girder was prepared as in case #2, with four debonded strands.

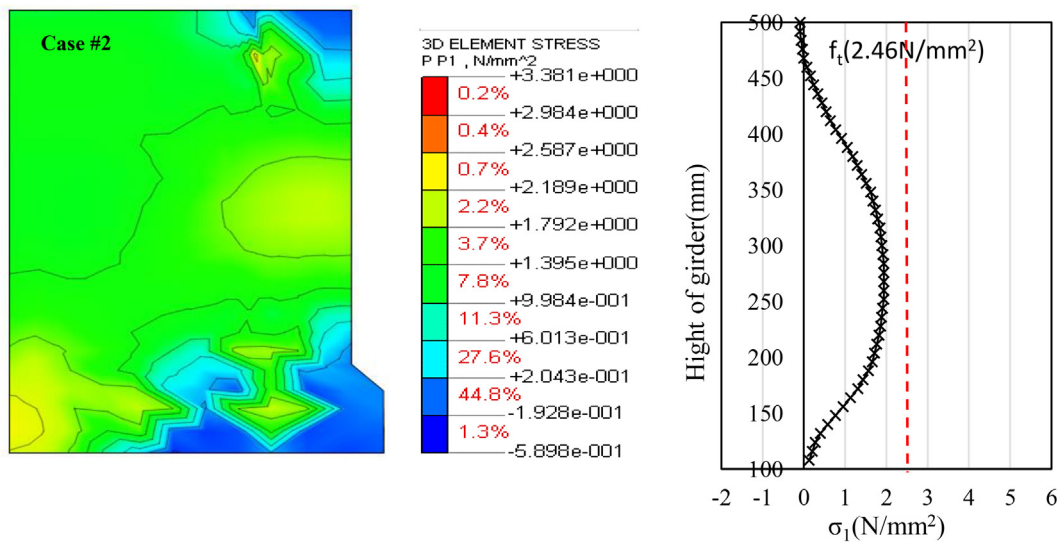
Fig. 13. Principal stresses in the half cross-section of girder in Case #2.

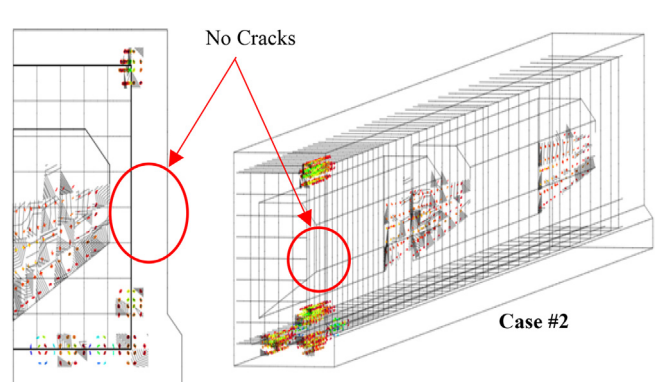
Fig. 15. End zone of girder without horizontal cracks.

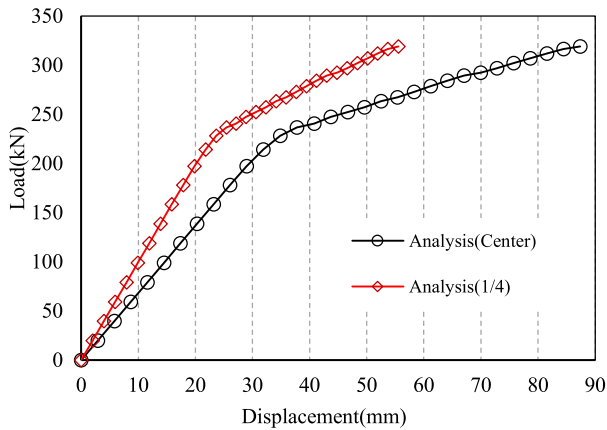
Fig. 16. Load–displacement results of numerical model.

The load–displacement and load–strain results obtained from the bending test simulations were analyzed. Fig. 16 shows the displacement of the girder at two locations, at the center and at one-quarter of the girder length. From the displacement and load graphs, it is observed that the girder behaved elastically until the yield point and began to deform with lower stiffness. Fig. 17 shows the compressive and tensile strains at the top and bottom fibers of the girder as a function of the applied load. The overall strain response remained elastic until the yield point before the strains started to increase.

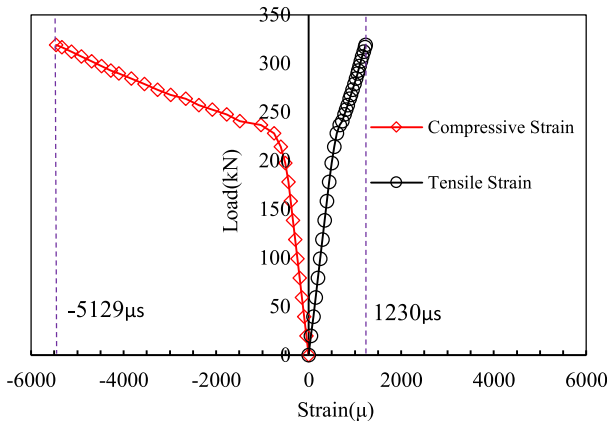
Fig. 17. Numerical model compressive and tensile strains at the middle of top and bottom girder fibers.

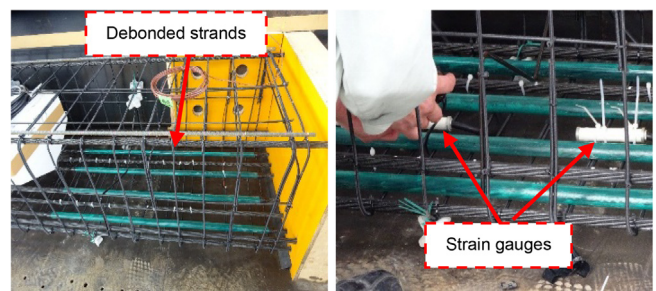
Fig. 21. Debonded strands and strain gauges at end of girder.

The girder was equipped with three 100 mm KM-100-type strain gauges connected to a data acquisition system (DAQ) to obtain the strains at the girder end where the prestress transfer takes place, as shown in Figs. 20 and 21. When concrete reaches its cracking limit and the stress magnitude abruptly decreases, the stress does not accurately describe the condition of the tested member in this case, although the strain still develops and indicates the loading condition. Thus, the strain was measured experimentally to investigate the behavior of the girder under several conditions; strain measurements were preferred over stresses. The corresponding effective stresses were computed from the measured strains using Hooke's law in Eq. (5).

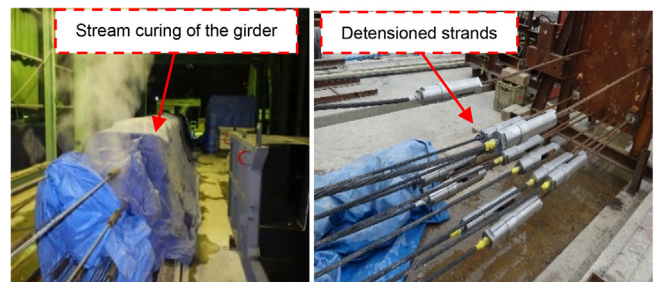
Fig. 22. Steam curing and detensioning process.

Detensioning was initiated by reducing the oil pressure on the hydraulic jack after 70% of the concrete strength was confirmed following 18 h of steam curing, as shown in Fig. 22. The process

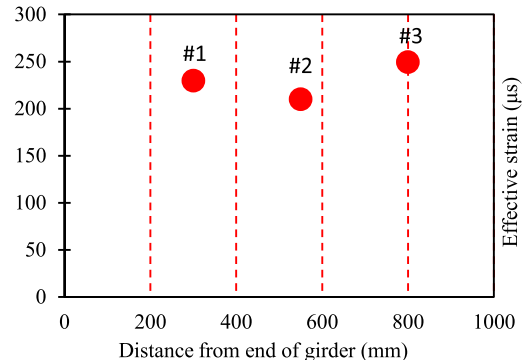
Fig. 25. Experimental strains along girder length after prestressing.

immediately after the strand release process. The strains measured by the embedded gauges are shown in Fig. 25.

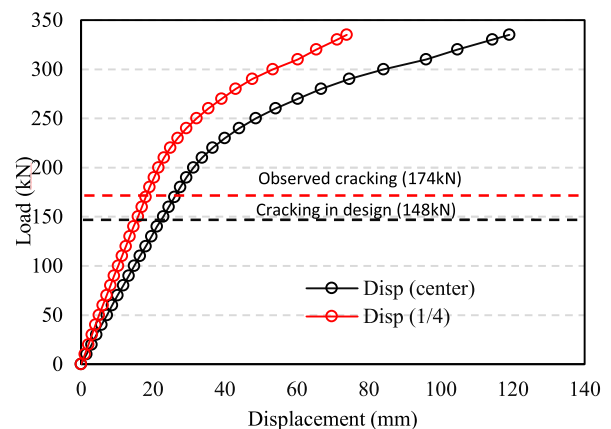
Fig. 26. Load-displacement relationship during bending test.

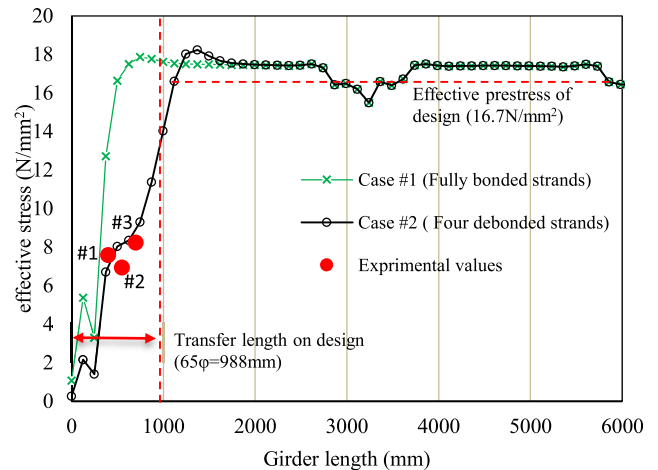
Fig. 29. Comparison of numerical and experimental effective stresses with the design value.

The effective stress distribution was assessed at the lowermost concrete fiber for the entire length using FEA, and compared with the effective stresses obtained from the experiment and the theoretical design value. The numerical effective stress values were in

good agreement with the experimental values and the theoretical values from Eq. (1), as shown in Fig. 29.

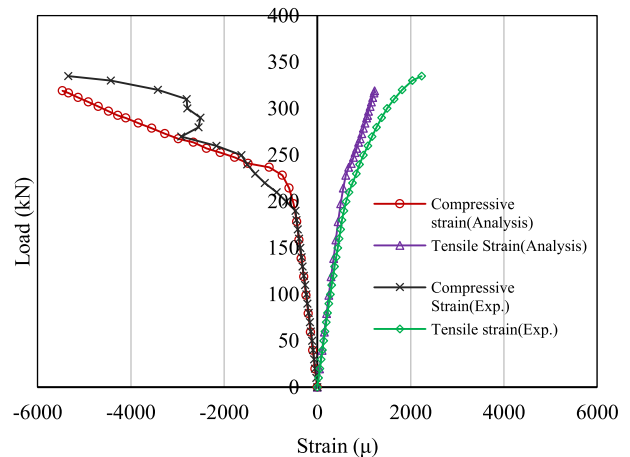
Fig. 30. Comparison of numerical and experimental compressive and tensile strains.

To validate the obtained results, load–strain and load–displacement curves of FEA model and experimental model were compared. Fig. 30 indicates the good agreement of both numerical and experimental results by showing bearing capability of hollow–type girders against vertical loads. Moreover, tensile and compressive strains of FEA model and experiment were also quite reliable as seen in Fig. 31.
