Engineering Science and Technology, an International Journal

Durability of preflex beam under cyclic loading

Ahmadullah Nasiri*, Tetsuhiro Shimozato

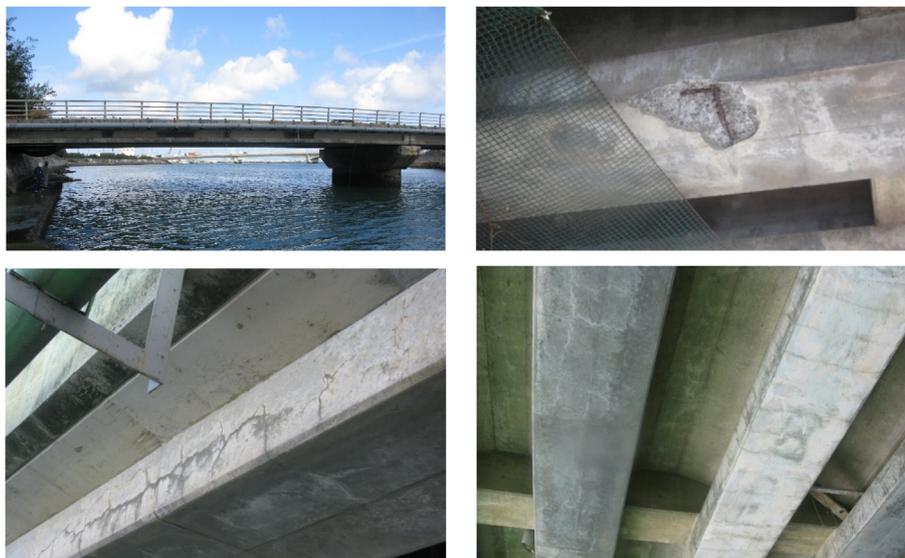
Fig. 1. Deteriorated preflex beam bridge.

This type of girders experience degradation as they undergo deterioration in the lower-flange concrete, under repeated application of service loads, and exposure to hazardous elements from humid and saline environments. This in turn leads to changes in structural behavior of composite member resulting in its reduced serviceability. Therefore, understanding the deterioration process of these girders under repeated service load, changes in their structural behavior, and other mechanical properties, is important. Fig. 1 shows a 40 years old preflex beam bridge with cracks in the lower-flange concrete and deterioration due to chloride ion penetration in a humid and severely saline environment.

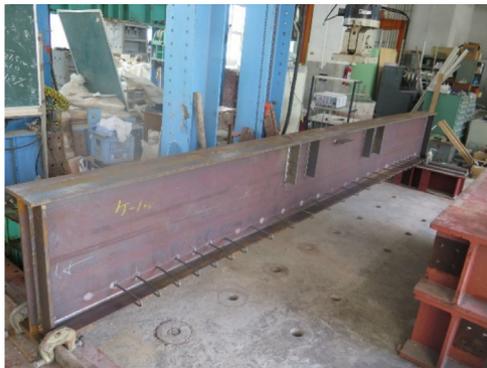
(b) Specimen in experiment laboratory.

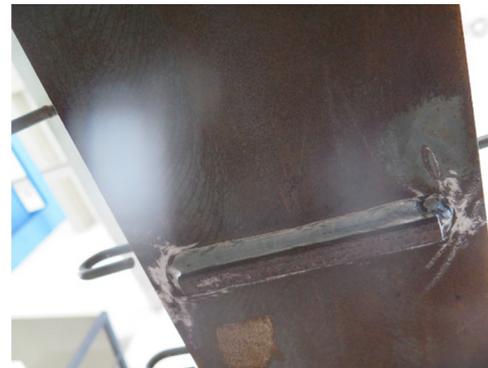
(c) Shear rib welded to the lower flange of the specimen.

ribs measuring 13 mm × 13 mm × 75 mm (width × height × length) spaced at 250 mm in one half (right half of Fig. 2(a), hereafter referred to as the 250-mm half) of the length and spaced at 500 mm in the other half (left half in Fig. 2(a) hereafter referred to as the 500-mm half), were welded to the bottom of the lower-flange (Fig. 2(c)), aimed at knowing the effect of shear rib spacing on concrete cracking behavior. All shear rib weld joints were fillet welds without any treatment, running all around the rib. Stud bars of 9 mm in diameter were welded to the web plate during fabrication to support the main reinforcement mesh (Fig. 2(b)).

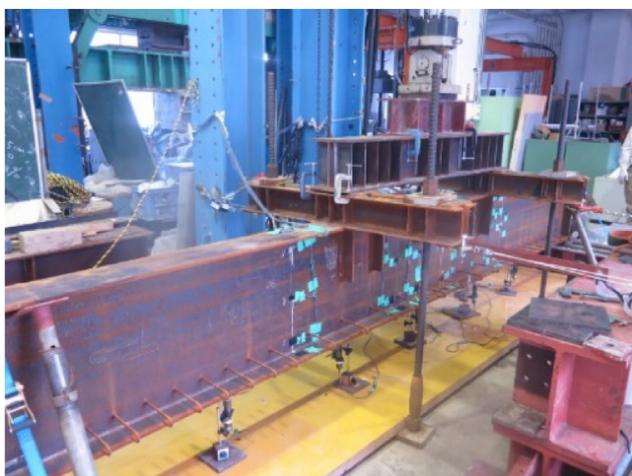
(b) Preflexion setup in laboratory.

Preflexion process was carried out using the four-point bending method, as shown in Fig. 5(a). A total of 330 kN was applied using the hydraulic jack, deflecting the specimen to 7.7 mm at the midspan. Subsequently, prestressing concrete (PC) bars with an inner diameter of 32 mm were fixed at the floor level and at the top of the specimen to steel parts laying on the upper flange of the plate girder forming a setup to maintain preflexion (Fig. 5(b)).
