## Displacement of dental implant into the maxilla : A case report

Takeshi Kano, Hajime Sunakawa, Akira Arasaki, Keiichi Arakaki  
Rika Kuninaka, Kiyomi Takara and Nanae Morita

*Department of Oral and Maxillofacial Surgery,  
School of Medicine, University of the Ryukyus*

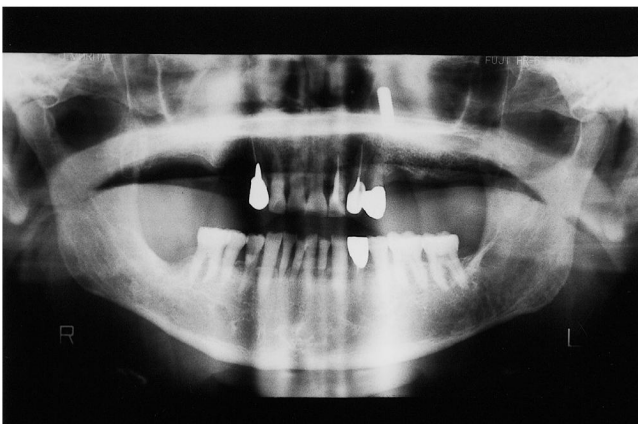
Fig. 1 Preoperative Panoramic radiograph showing dental implant displaced into the left maxillary sinus.

On examination of the oral cavity, the gingiva in the operative site showed no inflammatory changes. Radiographs showed the displaced implant in the left maxillary sinus, with no radiolucency of the maxillary bone around the implant (Fig. 1, 2). Tomography showed that the implant was attached to the medial wall of the maxillary sinus (Fig. 3).

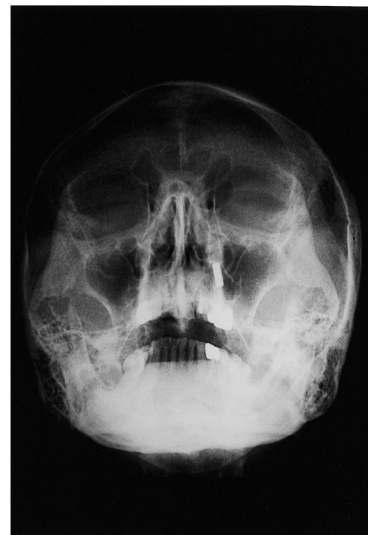
Fig. 2 Preoperative Occipitontal radiograph (Water's position).

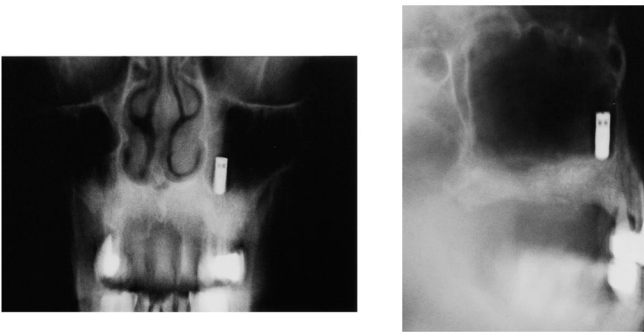
Fig. 3 Preoperative Tomography. (A) Coronal plane. (B) Sagittal plane.

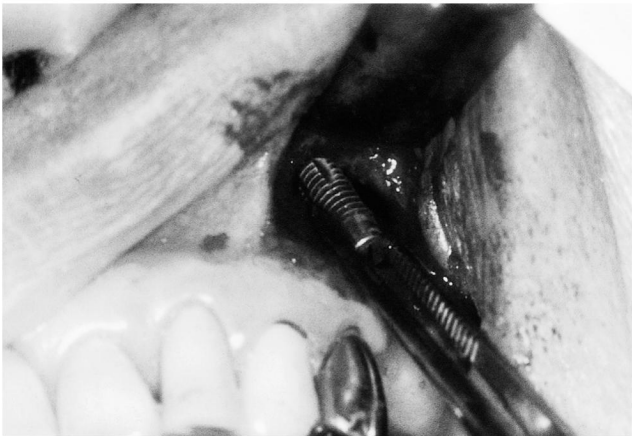
Fig. 4 Intra-operative view of the maxilla.

attached to the sinus membrane, and there were no inflammatory changes (Fig. 4, 5). The patient had an uneventful recovery. Postoperatively, there has been no evidence of sinus infection for 3 months. Radiographs showed no postoperative problems in the maxilla (Fig. 6, 7).

The displaced implant was removed via a sublabial antrostomy under local anesthesia. When the maxillary sinus was opened, the displaced implant was found

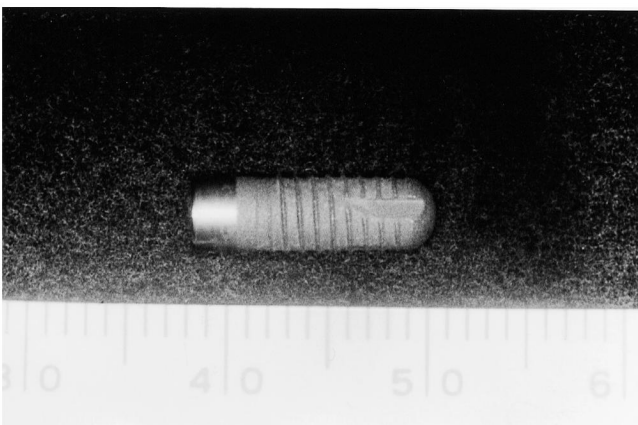
Fig. 5 Photograph of the removed dental implant.

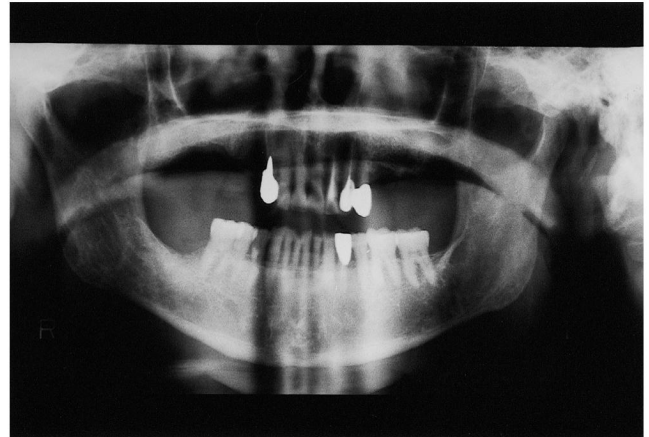
Fig. 6 Postoperative Panoramic radiograph. Follow-up radiograph 3 months after surgery showing no evidence of sinus infection.

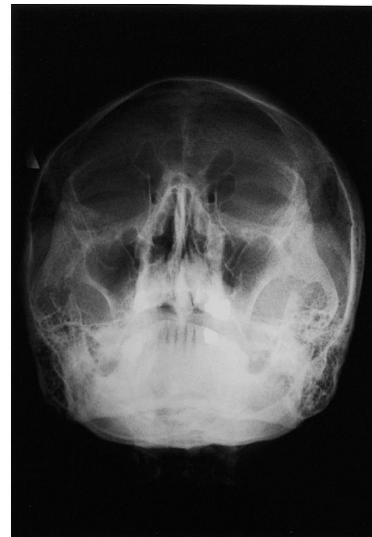
Fig. 7 Postoperative Occipitomental radiograph (Water's position).
