DInSAR Technique and Laser Scanning Technology and Their Utilizations in Rock Engineering and Natural Disaster Management and Prevention

Takashi Ito,* Ömer Aydan,** Naohiko Tokashiki***

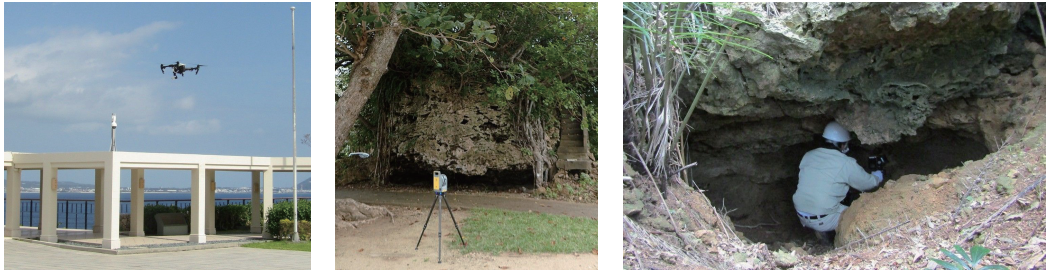
A. Drone

B. Laser Scanner

C. Hand-held scanner

FIGURE 3. Views of the utilization of a drone and laser scanners in the Ryukyu Archipelago.

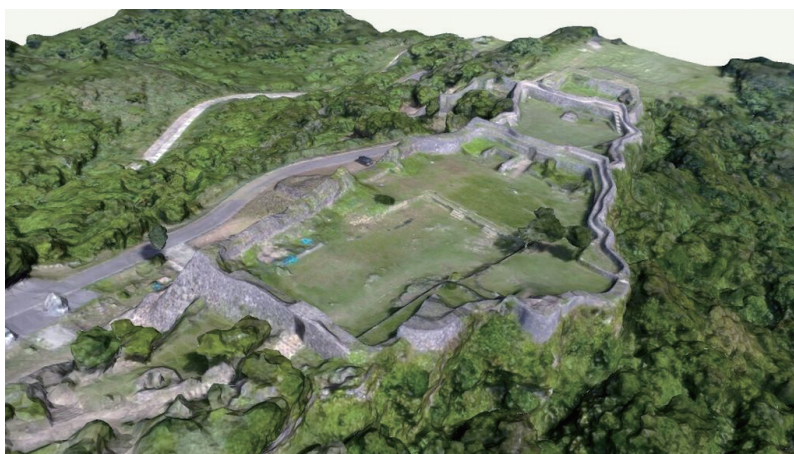
FIGURE 8. A 3D digitized image of Nakagusuku Castle.

have been involved with the Katsuren Castle and Nakagusuku tunnel, where the authors have been carrying out long-term monitoring and strong motion observations (fig. 7 and 8). The authors utilized the drone-based aerial photogrammetry technique to observe the current state of Katsuren Castle and Nakagusuku Castle, with particular attention to locations where continuous measurements were undertaken. These measurements are going to be repeated and compared with those from continuous monitoring results. The repetition of measurements using aerial photogrammetry is expected to provide the overall behavior of the castles three-dimensionally over the long term. This type of monitoring would also be the first of its kind in the world to utilize drone technology.

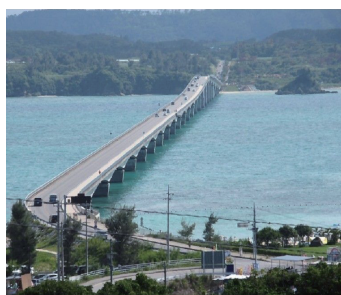
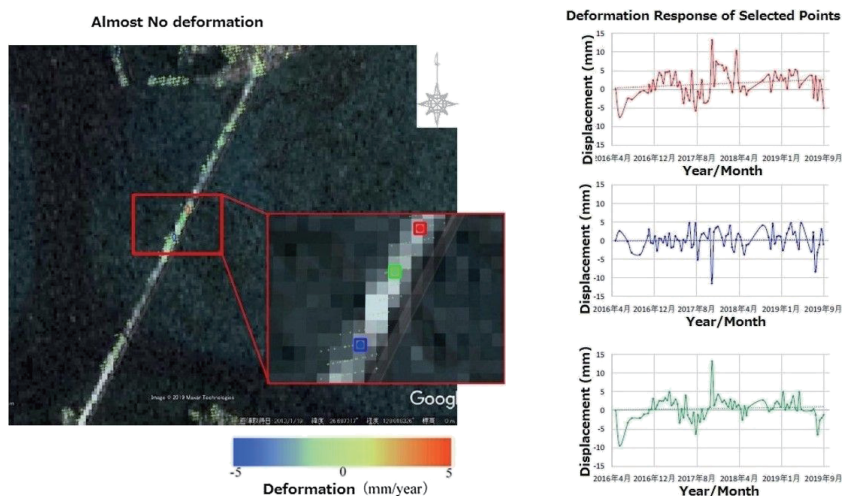
A. A view of the Kouri Bridge.

B. Selected points and their time-series data.

FIGURE 11. A view and time-series data of selected points obtained from SAR images.

There is a construction example in Okinawa Prefecture that the foundations of important structures such as bridges and tanks are not fixed on/into Ryukyu limestone formations due to the possibility of karstic caves beneath them. As a result, this design philosophy places a tremendous burden on the cost of the structures. Kouri Bridge, which is 1,960 m long, was built over a Ryukyu limestone formation having a thickness of 90–120 m. Bridge construction started in 1997 and was completed in February 2005. There was concern about settlement of the piles of the piers of the bridge. Sentinel SAR images taken between the period of April 2016 and September 2019 were utilized for assessing deformation of the bridge piers. Figure 11 shows a view of the bridge and time-series data for the selected time span. As noted from the figure, there was no settlement of the bridge itself, and this fact clearly illustrates the necessity of changing the design philosophy adopted in Okinawa Prefecture concerning structures built over Ryukyu limestone formations.

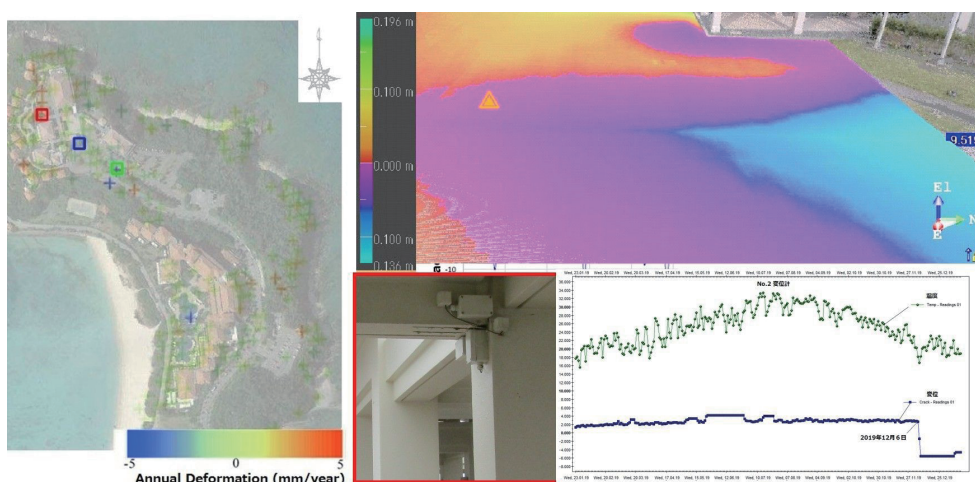
FIGURE 12. The integrated utilization of DInSAR, laser, and contact type monitoring technologies at a settlement site.

As mentioned in the introduction, integrated utilization of SAR, drone, and laser technologies together with contact type instrumentation for monitoring structures is desirable. The first implementation of this concept was done at a site where long-term subsidence of the ground was observed. At this site, Sentinel SAR images, laser technology, and contact type monitoring were utilized in an integrated manner (fig. 12). One of the important merits of DInSAR technology is that there is fundamentally no necessity to install instruments at the site. At this site, SAR images taken between the period of April 2016 and September 2019 were utilized for settlement evaluation. At the same site, laser measurements were taken, and it was found that about 100 mm of settlement had taken place since it was built in 1999. However, the settlement rate was quite high in recent years. For example, the contact type displacement was 8 mm during the period of January to December 2019. As this example shows, the integrated utilization of DInSAR, laser, and contact type monitoring technologies is quite promising.

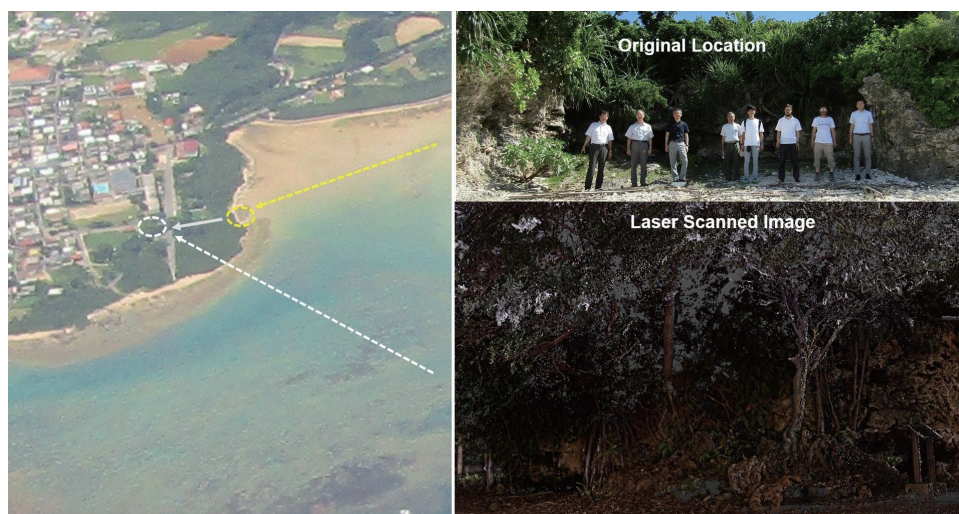
FIGURE 15. Aerial view of Ohama District and views of the tsunami boulder and its original location.

The Tsunami Boulder on Ishigaki Island. There are many tsunami boulders along the shore of Ishigaki Island. However, it is sometimes difficult to differentiate them from those boulders that have fallen onto the reefs due to toe-erosion induced by sea waves. Among them, a boulder in the Ohama District of Ishigaki Island on an elevated terrace was definitely upthrown over the terrace by a paleo mega-tsunami in the past (fig. 15). The situation of this tsunami boulder was also evaluated using ground-based laser-scanning technology.

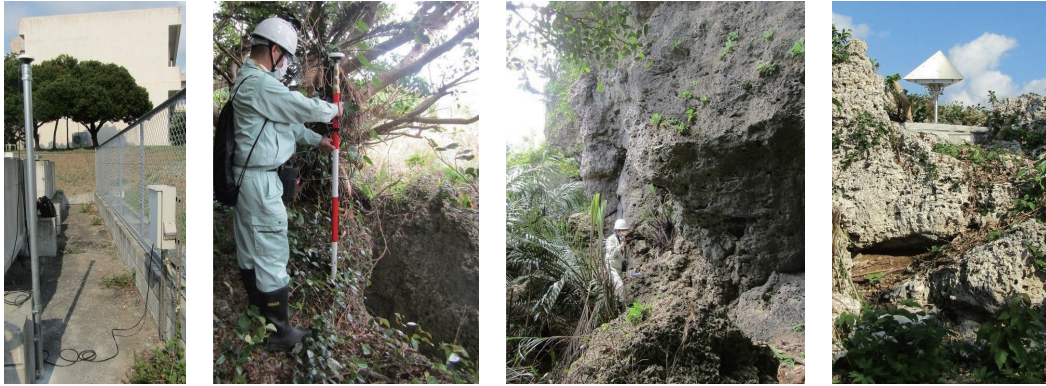
A. RTK B. Crack mapping C. Laser Scanning of the cliff D. Marker

FIGURE 18. Views of RTK, crack mapping, laser scanning of the cliff and the marker for SAR.

DInSAR analysis clearly showed that some movement along the cliff has been occurring (fig. 17C). A site investigation showed that there are open cracks at the crest of the cliff. The estimated thickness of the Ryukyu limestone formation is about 18–22 m at the site. Cracks are now mapped (fig. 18B) using a portable GPS (Global Positioning System) device with the support of an RTK (Real-time Kinematic) station on the grounds of the University of the Ryukyus (fig. 18A). It was decided to carry out some detailed investigations and analyses. For increasing the accuracy of SAR images at the cliff site, a marker station was established (fig. 18D).

A portable laser-scanning device was utilized to evaluate the condition and the geometry of the cliff (fig. 18C). Figure 19 shows the scanned image of the cliff shown in figure 18C. Despite very undesirable conditions for scanning, the geometry of the cliff was clearly obtained. The areas that cannot be scanned appear as dark areas in the images. Some of these dark areas correspond to cavities in the Ryukyu limestone formation. The height of the cliff was approximately 18 m high, which roughly corresponds to the thickness of the limestone formation. Furthermore, the erosion depth was up to 4 m.

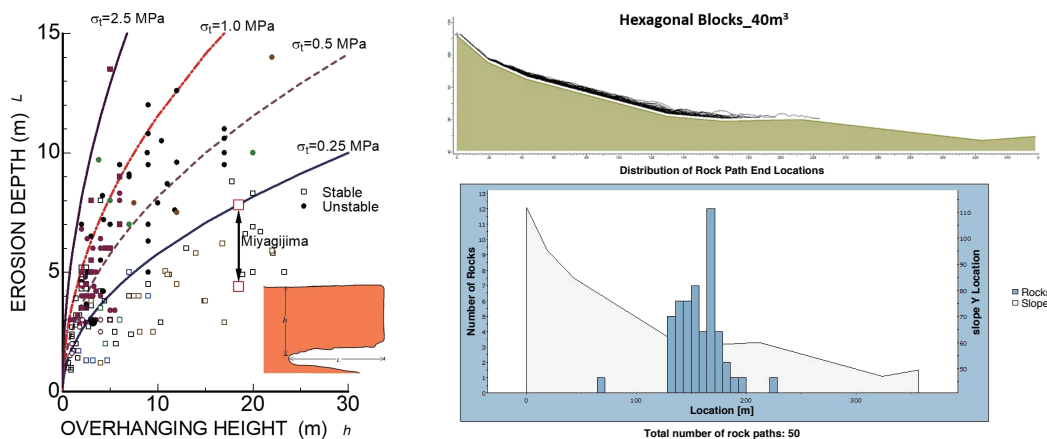
A. B.
 FIGURE 22A. Stability chart for cliffs on Miyagijima; B. travel distance of falling rock blocks.

differential weathering. Site investigations indicated that erosion depth is more than 4 m and less than 7 m. Besides gravity, heavy rainfall and/or earthquakes may impose lateral forces to induce cliff failures. Figure 22A shows the possible stability range for the Miyagijima cliffs for different tensile strengths of the Ryukyu limestone layer. It is very likely that the cliffs would be unstable under gravitational forces if the erosion depth is greater than 7.8 m for the given cliff height and the observations on the cliffs reported by Tokashiki and Aydan (2010). Figure 22B shows the travel distance of hexagonal-shaped rock blocks if a rockfall is initiated (Tunar-Özcan et al. 2021). It is very clear that the people in the village of Miyagijima are under great threat of rockfalls from the cliff. Therefore, some actions and countermeasures must be immediately activated against the possibility of rockfalls.
