## ON THE SHELTER EFFECT OF COASTAL FOREST AGAINST TSUNAMI

Kento Inagaki<sup>1</sup> · Eizo Nakaza<sup>2</sup> · Carolyn Schaab<sup>3</sup>

**Key Words :** *tsunami, coastal forest, Tohoku tsunami, tsunami inundation depth, tsunami mitigation*

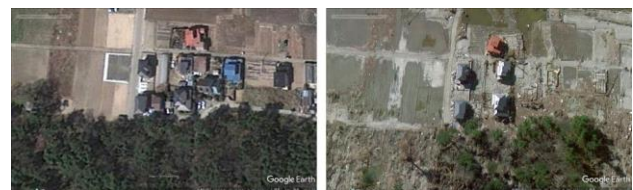
**Photo 4** Damages of the residential area where there was little coastal forest on the seaside front of it. (location ①)

In Photos 4 to 7, the left and the right sides show the situations before and after the disaster individually. As shown in Photo 4, around the point of ①, it is a residential area but there is no coastal forest on the sea side. Most of the structures in this area were swept away.

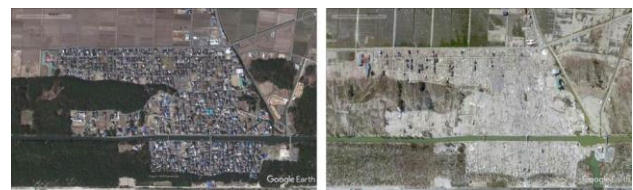
**Photo 5** A part of the coastal forest and a part of the houses that escaped from the tsunami. (location ②)

Around point ② shown in Photo 5, the houses collectively avoided run off. Most of the coastal forest was swept away but the density of the remaining coastal forest is high in places where the houses located behind also remained in place during the tsunami. In Photo 6, the point of ③ is an area where a residential land zone was close to the coastal line; almost all the houses as a result were swept away. However, in the upper left portion of the photo, it was possible to confirm several houses remaining behind the forest zone, which is about four times of the size of the right area. The remaining houses exist along the streaking patches of trees that endured against tsunami.

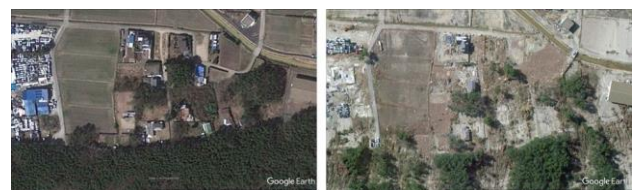
**Photo 6** Photo 6. Damage to the residential area where the coastal forest had a short width (some houses remained on the left side where the width of the vegetation area was about four times of that of the right side. (location ③).
