Perspectives on the Resilience of Okinawan Housing against Typhoons

Juan Jose Castro*

Typhoon damage, reinforced concrete structures, wooden structures, housing resilience

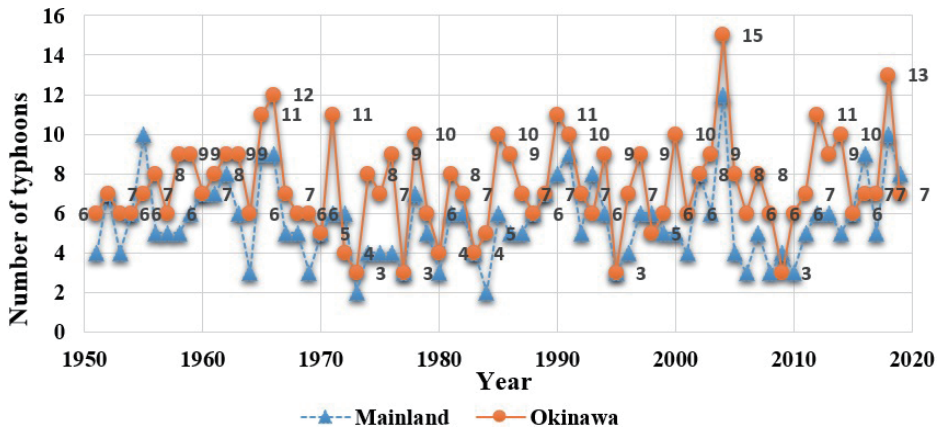
FIGURE 1. Record of typhoons

The frequency of typhoons is summarized in figure 1 from the year 1950 up to the present. The typhoons included in figure 1 are those whose paths were within a radius of 300 km from the Okinawa Islands. Figure 1 also shows those typhoons that struck the mainland of Japan. Notably, the number of typhoons that hit the Okinawa Islands is significantly more than those that reached the mainland (Amano 1988), indicating that the southern islands are prone to more damage from typhoons. Table 1 shows the ranks of the typhoon intensity given by the Japan Meteorological Agency. The maximum velocity indicated in the table represents the maximum value of 10 minutes average velocity.

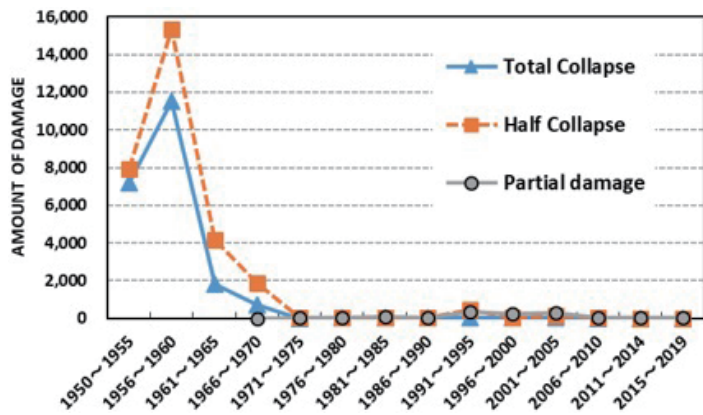
(a) Structural damage to houses

This section looks at the trends in damage to houses caused by typhoons since 1950. The damage is grouped in five years intervals. Figure 3 shows the amount of structural damage and inundation. The number of damaged houses in terms of total damage and half damage peaked between 1956 and 1960, then decreased quickly after 1970, as shown in figure 3 (a) (Asato 2016).

FIGURE 3. Variation in damage by year

As discussed in previous sections, the amount of damage caused by typhoons decreased after 1970, as shown in figure 3. The reason for the decrease can be addressed in terms of reinforced concrete and wooden structures, respectively.

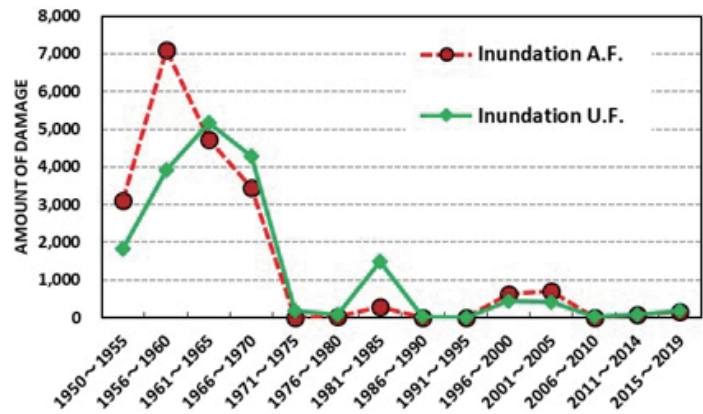
(b) Inundation of houses

The amount of damage caused by inundations shows a trend similar to that of structural damage, with a peak between 1950 and 1960, as shown in figure 3 (b). However, in the mid 1980s and between 2001 to 2005, there were many cases of inundation of houses due to heavy rainfall.

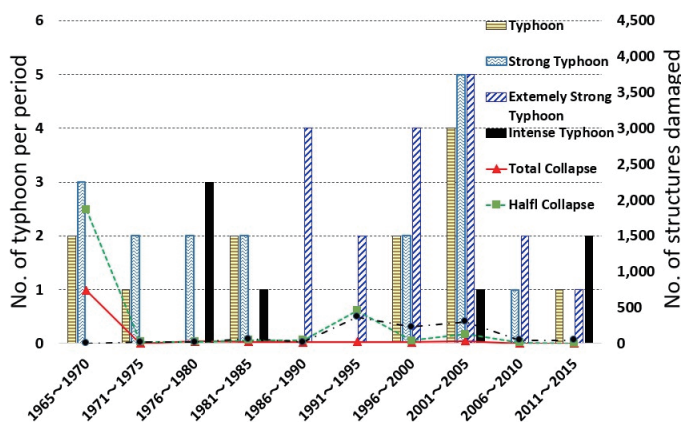
(a) Structural damage to houses

Figure 4 shows structural damage by wind and that caused by inundations between 1965 and 2015 for the Okinawa main island only. These figures also include the intensity

of the typhoons according to the scale given in table 1. As shown in figure 4 (a), for the period between 1976 to 2015, even though there were events classified as “extremely strong typhoon” or “intense typhoons,” the amount of structural damage was less compared with the period before 1970. This indicates an improvement in the structural resilience of houses, as will be explained in the latter part of this chapter. On the other hand, even though damage by inundation showed a conspicuous decrease after 1975, there were some periods such as 1991–1995 and 2000 – 2005, with cases of substantial inundation damage. This may indicate that Okinawan houses were still not resilient enough against typhoons that produced intense rainfall.

FIGURE 4. Variation in damage by year and typhoon intensity

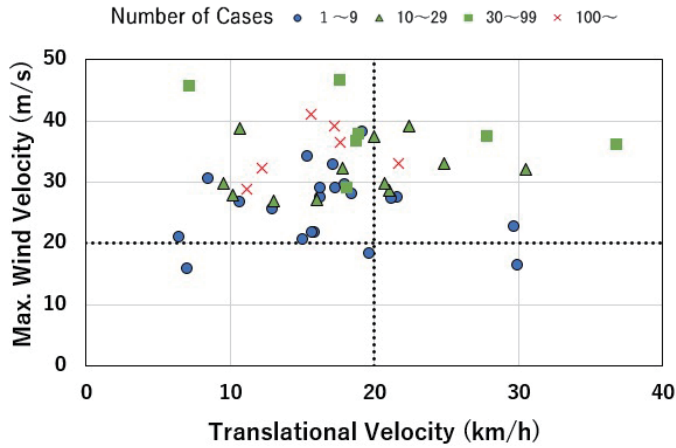
The amount of damage produced by typhoons is closely related to their translational velocity, or how fast they move from one point to another, and wind velocity. As shown in figure 5, the damage is concentrated in the region where the translational velocity of a

typhoon is under 20 km/h and the wind speed is greater than 25 m/sec (Sunakawa 2019).

FIGURE 5. Damage distribution according to typhoon velocity and wind speed

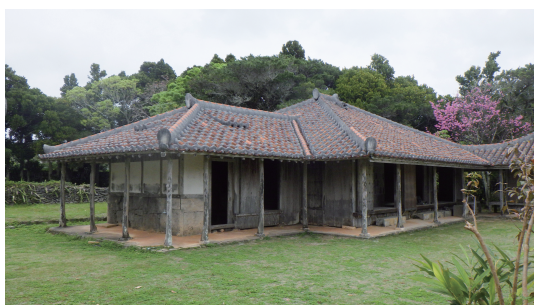
From the Meiji era to WWII, the conventional construction material used was wood. The traditional Okinawan house structure (kominka house) was composed of vertical (columns) and horizontal (beams) elements without foundations. Some of these traditional houses constructed during the Meiji and Taisho era still remain in good condition, as shown in figure 7. Traditional houses used thatched roofs until the late nineteenth century. Later, the roof material was gradually changed to red tile, as shown in figure 8. These changes in the roof material enhanced the resistance of the houses against strong winds due to their heavier weight. Before construction, local wood materials used in those traditional houses were placed in salt water to prevent insect damage (Chinen 2018).

FIGURE 7. Okinawan kominka house (Izena Island, constructed in 1906)

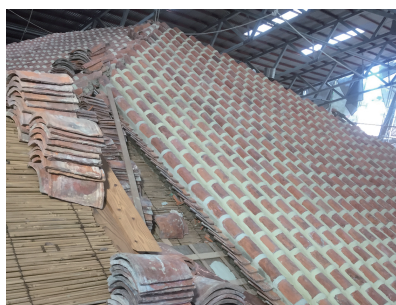
FIGURE 8. Red tile roof under repair

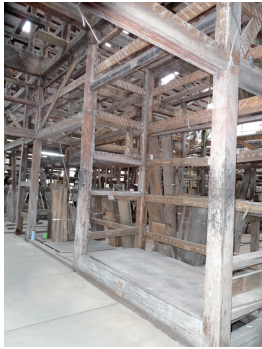
The joints of the structural elements of these traditional houses were made without using nails or any other metal connectors (see fig. 9). The carpenters carved the wood elements on construction sites to join them together, as shown in figure 10. Recent research showed that traditional houses could sustain wind forces with average wind velocities up to 40 m/sec as long as the wood materials did not have pronounced aging deterioration (Omi 2019). In other words, the traditional houses were strong enough to withstand

FIGURE 9. Kominka house (Nago, 1906)

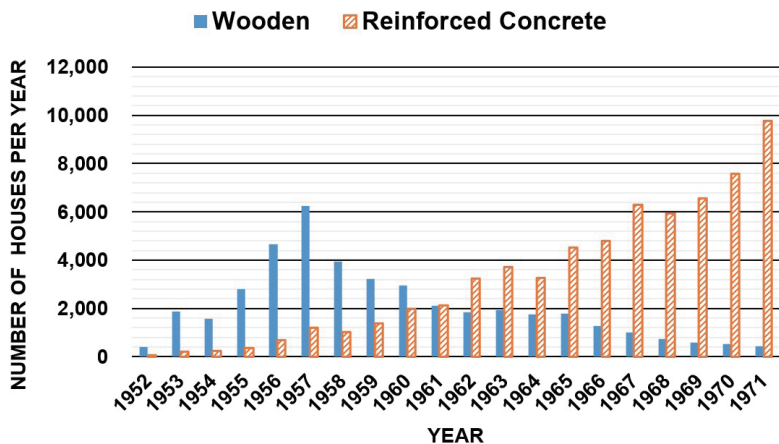
As shown in figure 12, wooden houses continued to be the most commonly constructed until 1957, in accordance with the traditional Okinawan house style (Tamaki 2014a). However, as construction costs became lower due to the local availability of concrete materials, reinforced concrete structures became popular. As a result, the number of newly constructed wooden houses decreased, and by 1962, reinforced concrete houses became the most common type in Okinawa.

FIGURE 12. Number of houses constructed per year

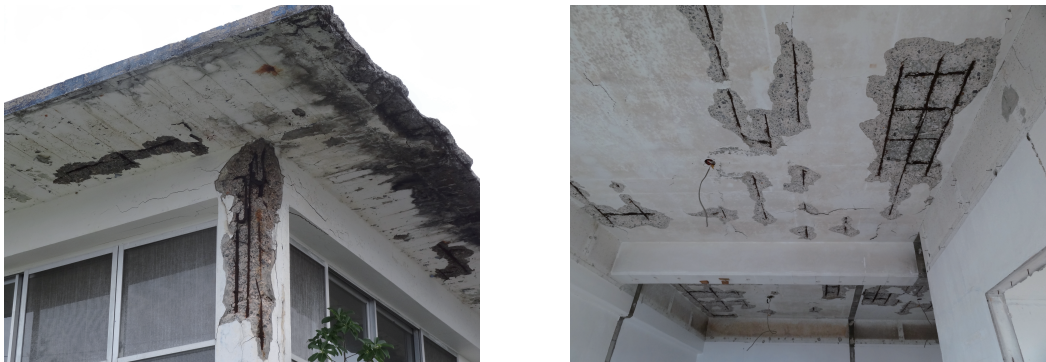
A lack of appropriate natural resources and facilities led to the use of marine sand. In many cases, the concrete was mixed at the construction site with poor control over the water-cement ratio. For instance, at a construction site, water was added to enhance the workability of the concrete. The addition of water to the concrete decreased the concrete strength and durability (see fig. 13).

FIGURE 13. Concrete deterioration due to salt content

tent of concrete sand was as high as 0.14% in Okinawa during this time. Many houses, as shown in figure 13, constructed of concrete with a high salt content still remain in Okinawa islands. These structures have not collapsed due to typhoons, but the deteriorated concrete may peel off, producing so-called partial damage to the structure.

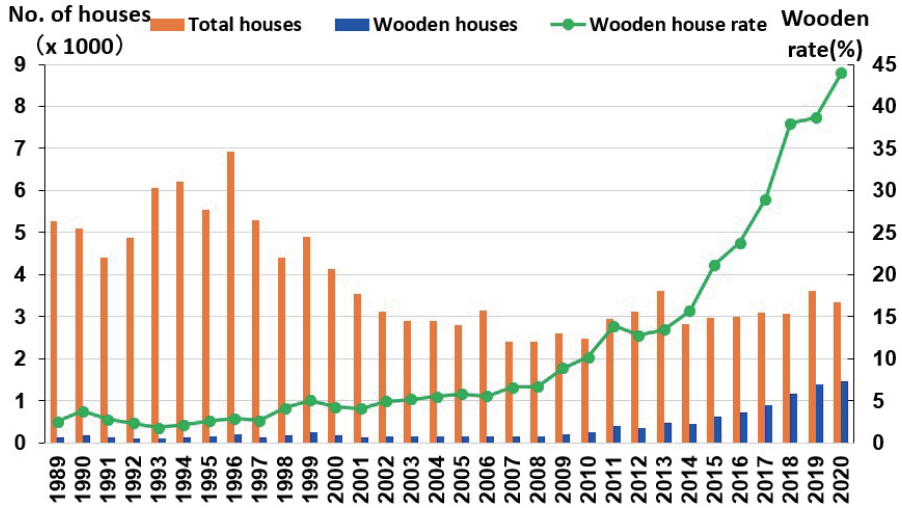
Based on the new concepts for the structural design of wooden houses and promotion of subsidies, by the year 2010, local construction builders started promoting wooden houses, beginning that year with 3% of the total new houses constructed and reaching 40% in 2020, as shown in figure 14.

FIGURE 14. Number of houses constructed per year after 1989

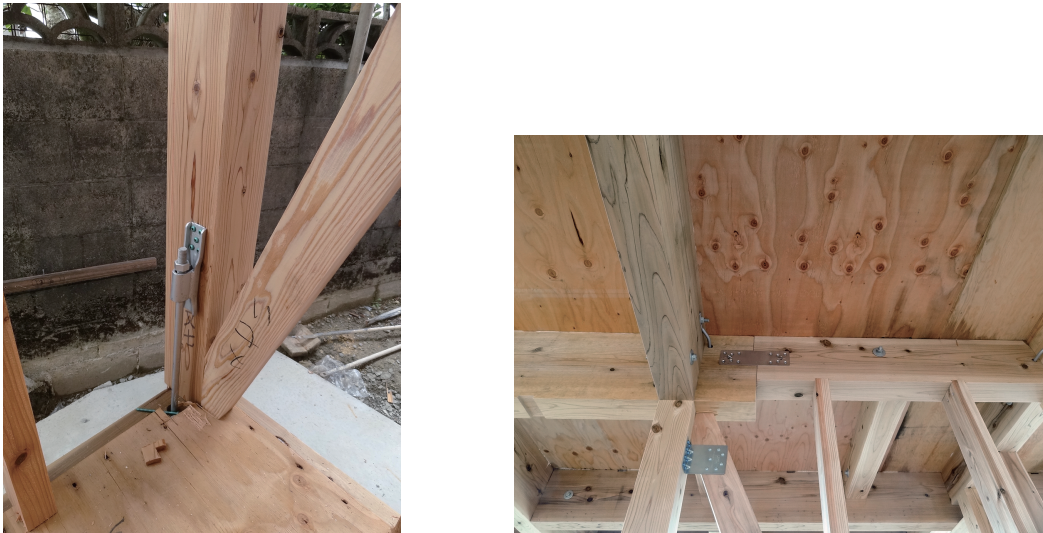
The structural calculations of these wooden-frame type houses are designed to resist wind velocities up to 46 m/sec, which is the reference wind velocity assigned to the Okinawa Islands by the building standard law (Hasegawa 2013). Unlike the traditional houses and the standardized houses, there is no reported damage for these types of wooden-frame houses. Third, the development of new steel connectors for structural joints makes them strong enough for strong winds (see fig. 15). These steel connectors join the structural elements in both horizontal and vertical directions, increasing the structures' stiffness.

FIGURE 15. Steel connectors in wooden houses
